Manhole Inspection Summary

Manhole # S01I2012MH

Insp Date: **8/7/06 11:11 AM**

Location Address: **3100 Fomarc Ct**

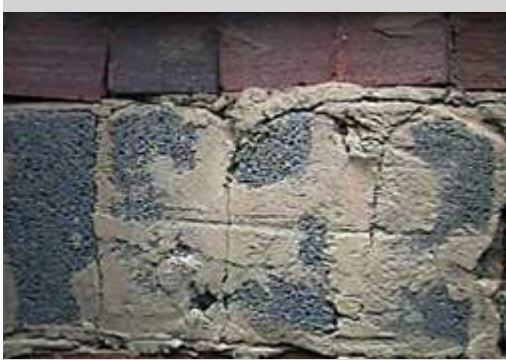
adjustment

Chimney / Frame Adjustment ☒ Exists Material: **Brick and Concrete** ☐ Parged Height: **16** (in.)

Condition: ☒ Sound ☐ Cracked ☐ Root Intrusion ☐ Loose Brick ☐ Deteriorated

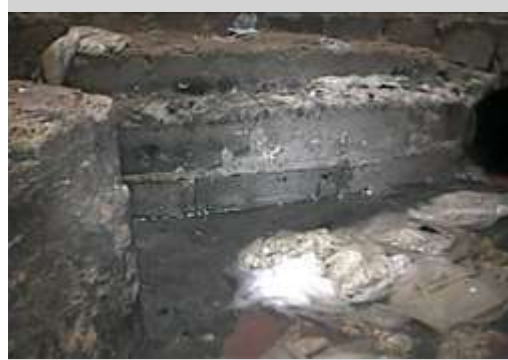
Defect

Condition: ☐ Sound ☐ Cracked ☐ Root Intrusion ☐ Deteriorated ☐ Leaks ☒ **Debris**

debris in channel

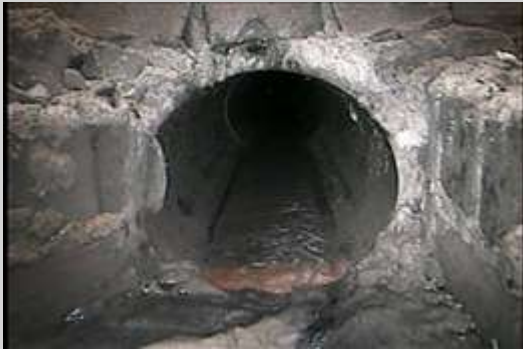
8 in. Circular Gravity Sewer Pipe Out @ 12 O'Clock

Pipe Material: **Clay** ☐ Pipe Lined

Invert Depth: **10.42** (ft.) Flow Characteristics: **Slow**

Deposits: ☒ None ☐ Mud ☐ Sludge ☐ Debris ☐ Grease

Infiltration: **None** Pipe Seal Cond: **Sound**

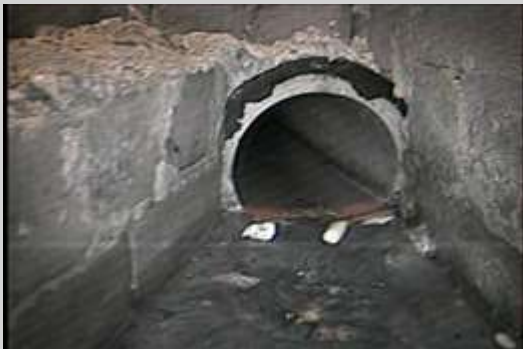
8 in. Circular Gravity Sewer Pipe In @ 6 O'Clock

Pipe Material: **Clay** ☐ Pipe Lined

Invert Depth: **10.40** (ft.) Flow Characteristics: **Slow**

Deposits: ☒ None ☐ Mud ☐ Sludge ☐ Debris ☐ Grease

Infiltration: **None** Pipe Seal Cond: **Sound**

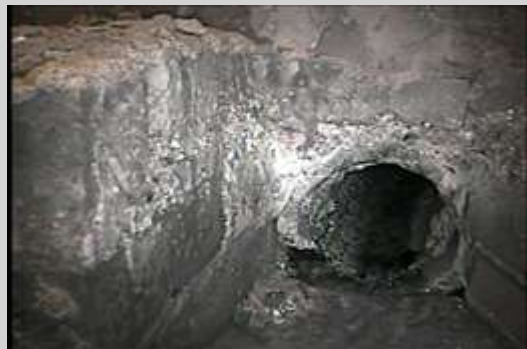
6 in. Circular Gravity Sewer

Pipe Material: **Clay**

Invert Depth: **10.30** (ft.) Flow Characteristics: **Slow**

Deposits: ☒ None ☐ Mud ☐ Sludge ☐ Debris ☐ Grease

Infiltration: **None**

Pipe Seal Cond: **Sound**
